Manhole Inspection Summary

Manhole # S31A__008MH

Insp Date: **8/17/09 1:44 PM**

Location Address: **305 MONUMENT ST**

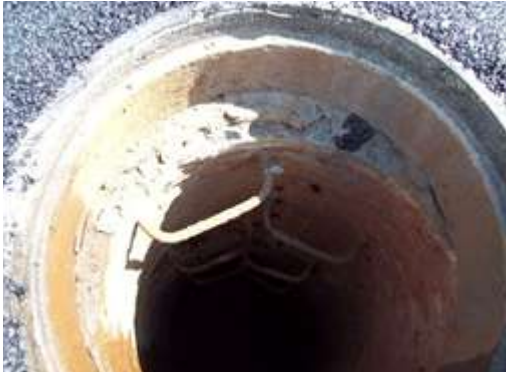
Defect 1

Offset: **3** (in.)

OFFSET

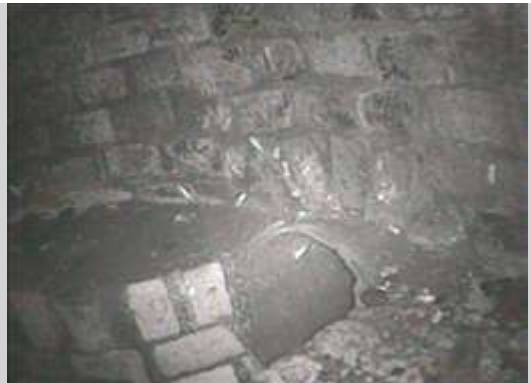
12 O'Clock Outflow

10 in. Circular Gravity Sewer
Pipe Out @ 12 O'Clock

Pipe Height: (in.) Direct
Pipe Material: **Clay** ☐ Pipe Lined
Invert Depth: **13.25** (ft.) Flow Characteristics: **None**
Deposits: ☒ None ☐ Mud ☐ Sludge ☐ Debris ☐ Grease
Silt Depth: (in.) Deposits Extent:
Infiltration: **None** Pipe Seal Cond: **Sound**

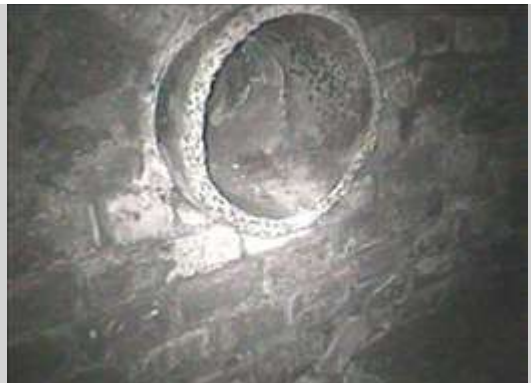
6 O'Clock Inflow

10 in. Circular Gravity Sewer
Pipe In @ 6 O'Clock

Pipe Height: (in.) Direct
Pipe Material: **Clay** ☐ Pipe Lined
Invert Depth: **11.54** (ft.) Flow Characteristics: **None**
Deposits: ☒ None ☐ Mud ☐ Sludge ☐ Debris ☐ Grease
Silt Depth: (in.) Deposits Extent:
Infiltration: **None** Pipe Seal Cond: **Sound**

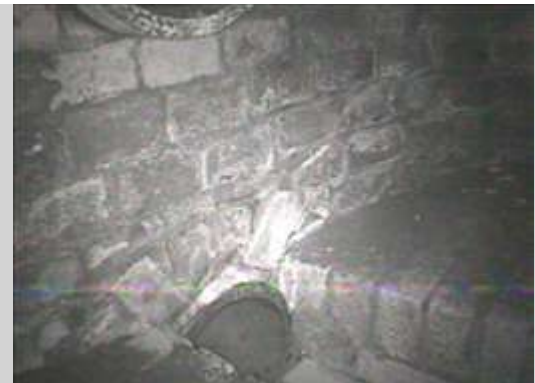
Drop In @ 6 O'Clock

Drop: **Outside Direct**
Angled: Reading: (ft.)
Inv Depth: **13.22** (ft.)
Drop Condition: **Open**

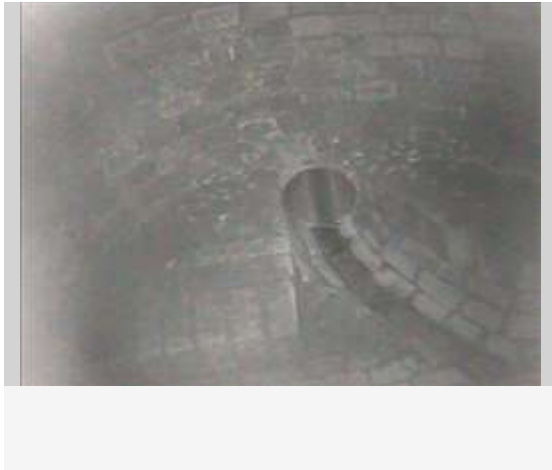
9 O'Clock Inflow

8 in. Circular Gravity Sewer

Pipe In @ 9 O'Clock

Infiltration: **None** Pipe Seal Cond: **Sound**
